River Kennet Flooding at Pingewood, January 2024

An already bad situation made worse

Report by Martin Salter and Del Shackleford, Reading and District Angling Association

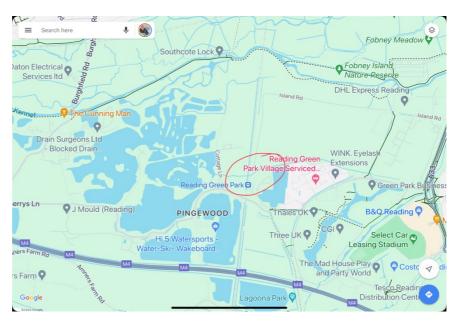
2) Map of the area with the culvert and flood relief channel marked and circled

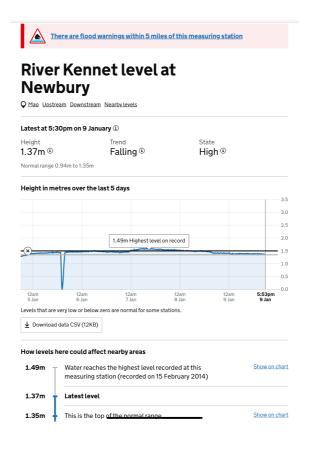
As the EA gauge reading on the chart below illustrates the flood predictions were entirely accurate with record water levels in the Kennet at Newbury registering by the morning of Sunday January 7th at 1.59 metres compared with the previous record high of 1.49 in 2014.

3) EA water level gauge showing record levels on the Kennet at Newbury by Jan 7th

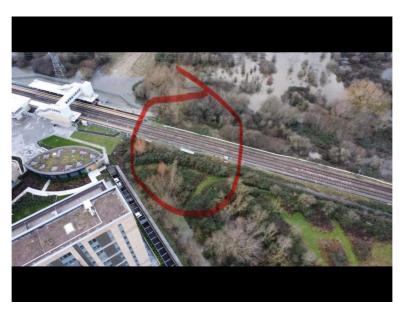
4) Drone footage taken on January 6th showing the difference in flooding west and east of the railway due to the blocked culvert

In order to demonstrate the effect of the blocked culvert, RDAA took drone footage of the flooded area on Saturday which clearly shows the flooding caused by the huge volume of water backed up to the west of the railway tracks, while the water meadows to the east remain completely clear of any significant surface water. Further evidence was supplied to the Joint Emergency Planning Unit comprising three videos and photographs from Monday (Jan 8th) which clearly illustrated:

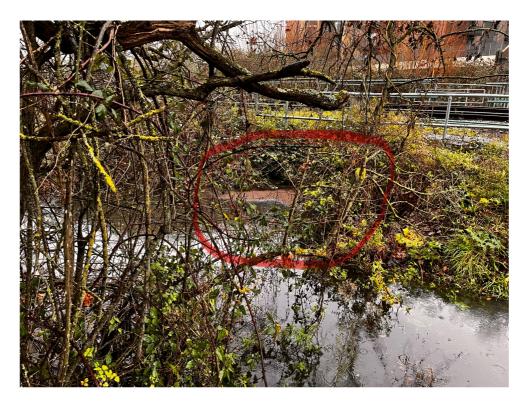
6) The blocked culvert under Green Park station caused increased and avoidable flooding, damage and hardship to people and premises west of the railway tracks

Network Rail have clearly been negligent in failing to ensure that the culvert was kept clear with only one of three pipes able to convey water to the east of their railway tracks. This is despite the recommendations of the 2014 Flood Review and the problem being identified during the planning process in 2019 for the new £20m Green Park Station.
